Operating Experience Weekly Summary 97-24

June 6 through June 12, 1997

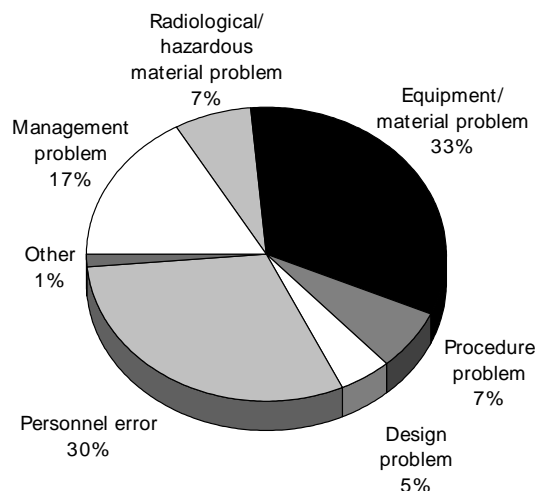
Figure 1-1. Direct Cause of Contamination Events DOE-Wide¹

Operating Experience, Analysis and Feedback (OEAF) engineers searched the Occurrence Reporting and Processing System (ORPS) database for personnel contamination events and found 2,675 reports for 2,897 occurrences. Figure 1-1 shows the distribution of direct causes for contamination events DOE-wide from 1990 to present. Equipment failure and personnel error

were the two largest contributors, comprising 63 percent of the events. Communication problems comprised 3 percent of the personnel errors.

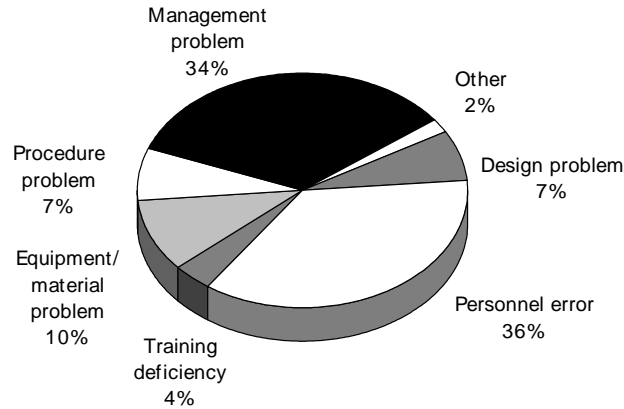
Figure 3-1. Root Causes for Lockout/Tagout Events DOE-Wide¹

OEAF engineers searched the Occurrence Reporting and Processing System (ORPS) database for reports involving lockout/tagout events and found 1,462 occurrences DOE-wide. Figure 3-1 shows the distribution of root causes reported by facility managers for these events. Personnel error represented 36 percent of the root causes; management problems represented 34 percent. Further review of the personnel errors shows that 44 percent were caused by inattention to detail and 43 percent by procedure not used or used incorrectly. A review of the management problems shows that 35 percent were caused by policy not adequately defined, disseminated, or enforced.
